**Steam Incident Investigation at
East 41st Street and Lexington Avenue
New York, NY**

**July 18, 2007 Steam Incident Investigation
At East 41st Street and Lexington Avenue
New York, NY.**

Report No. 1763931-R-001

ABSG Consulting, Inc. (ABS Consulting)
Northeast Area Office
118 Portsmouth Avenue
Stratham, NH 03885

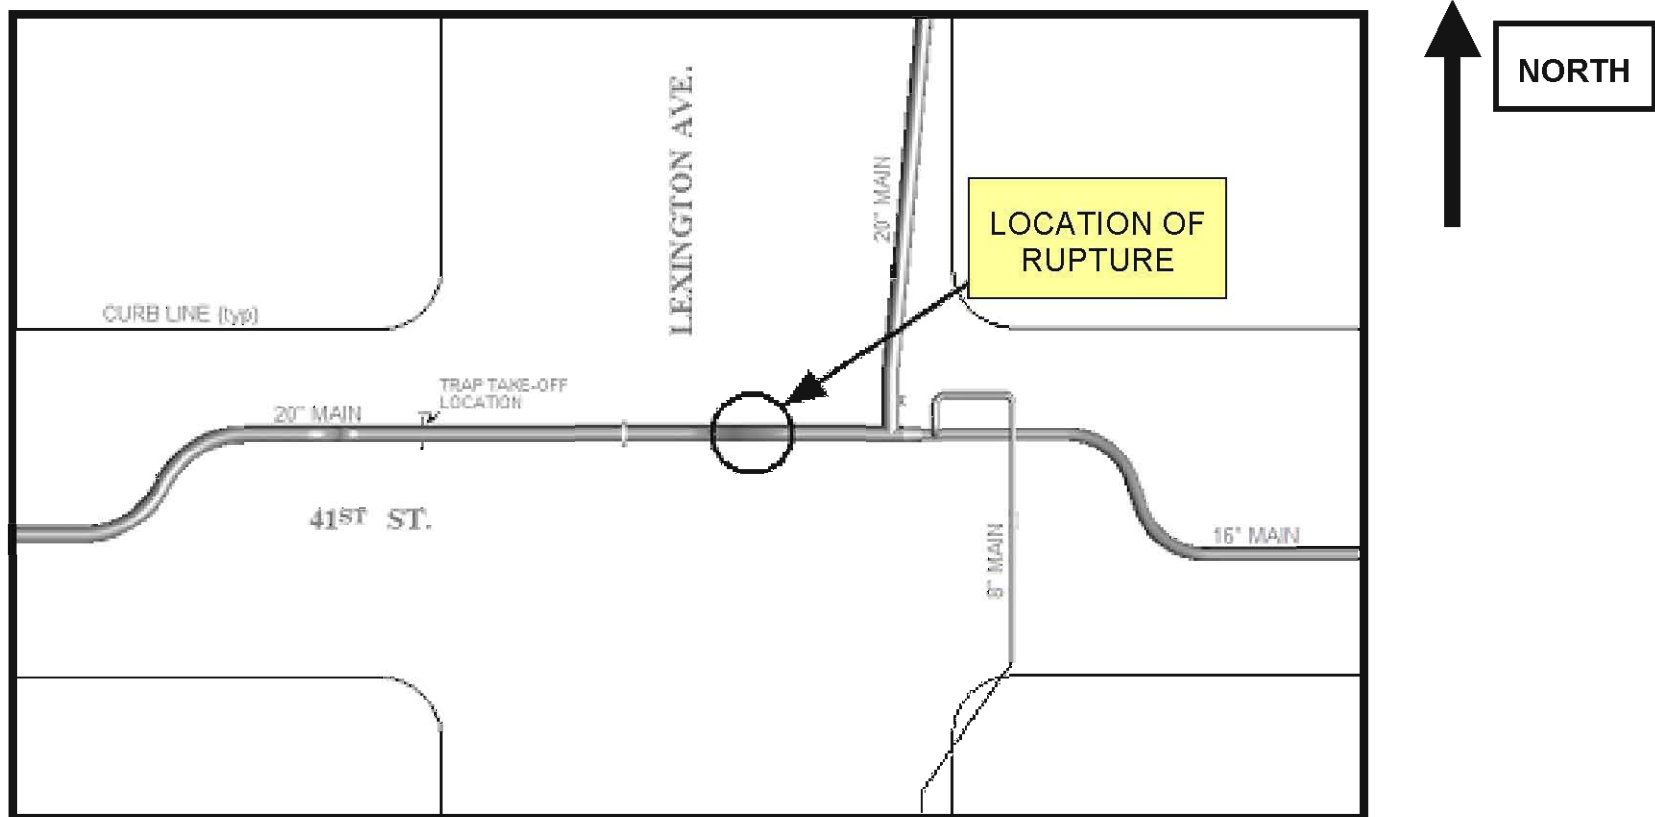
Figure 1-1: Plan View of Steam Main Configuration at Incident Site

(Rupture location is in a vertical plane bend; referred to as a "File 3 bend", see Figure 1-2 for elevation view)

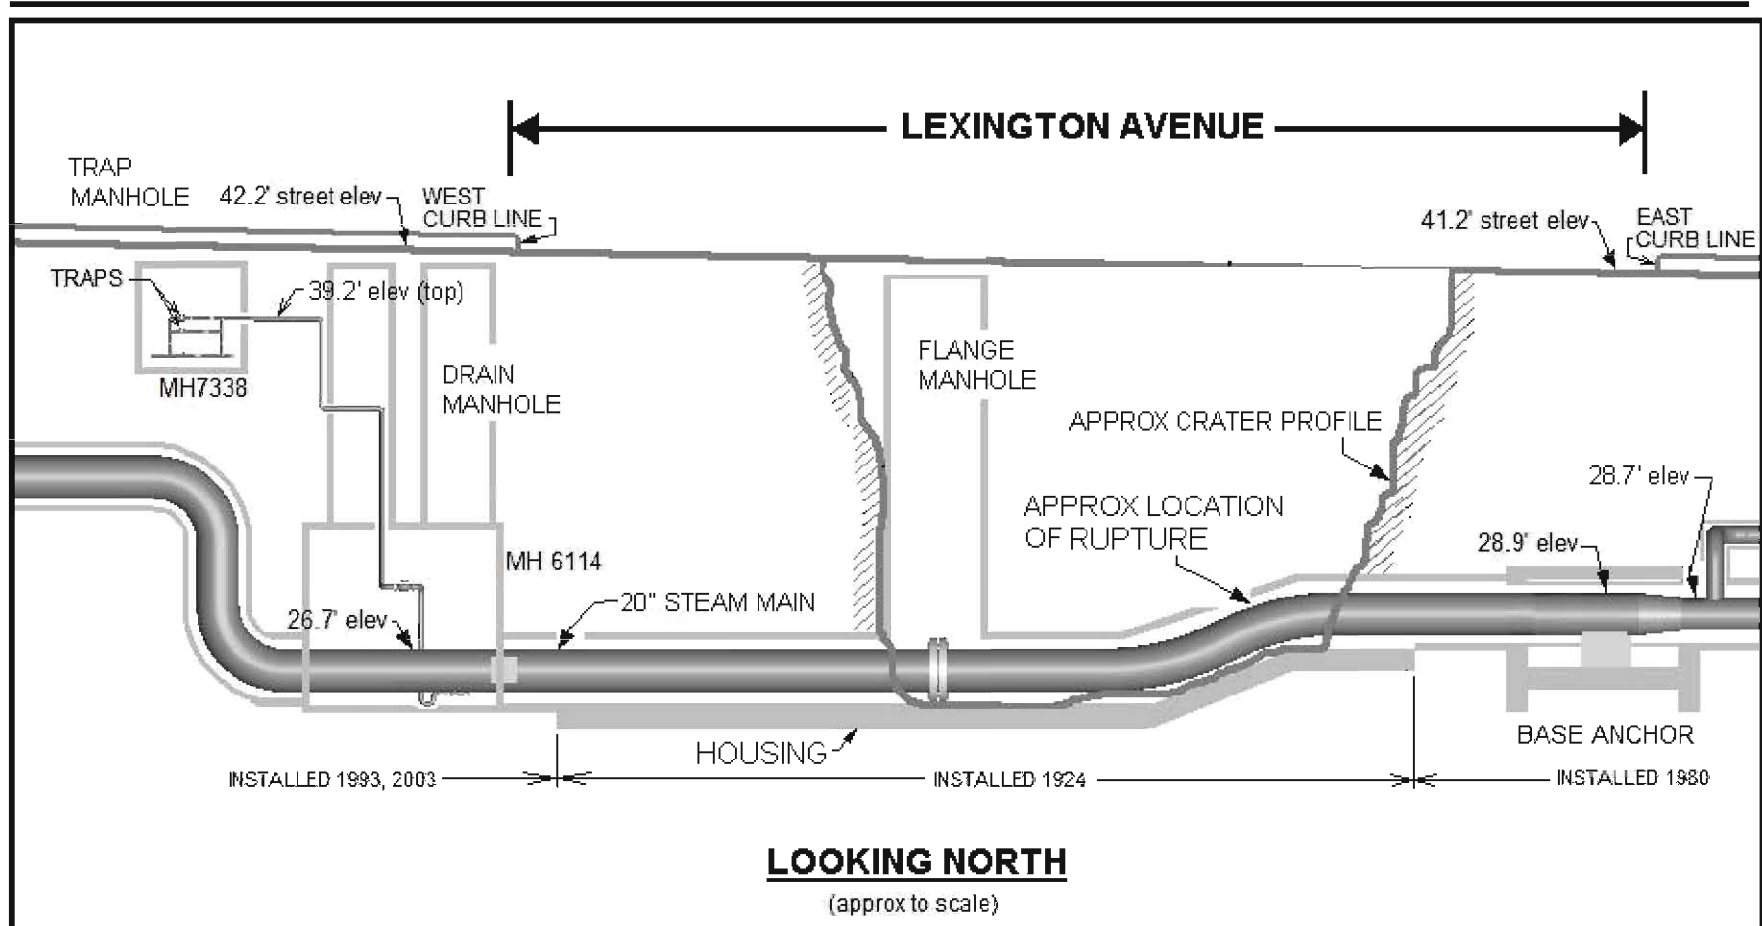
Figure 1-2: Elevation View of Steam Main Beneath Lexington Avenue

(Identified elevations are based on Manhattan datum)

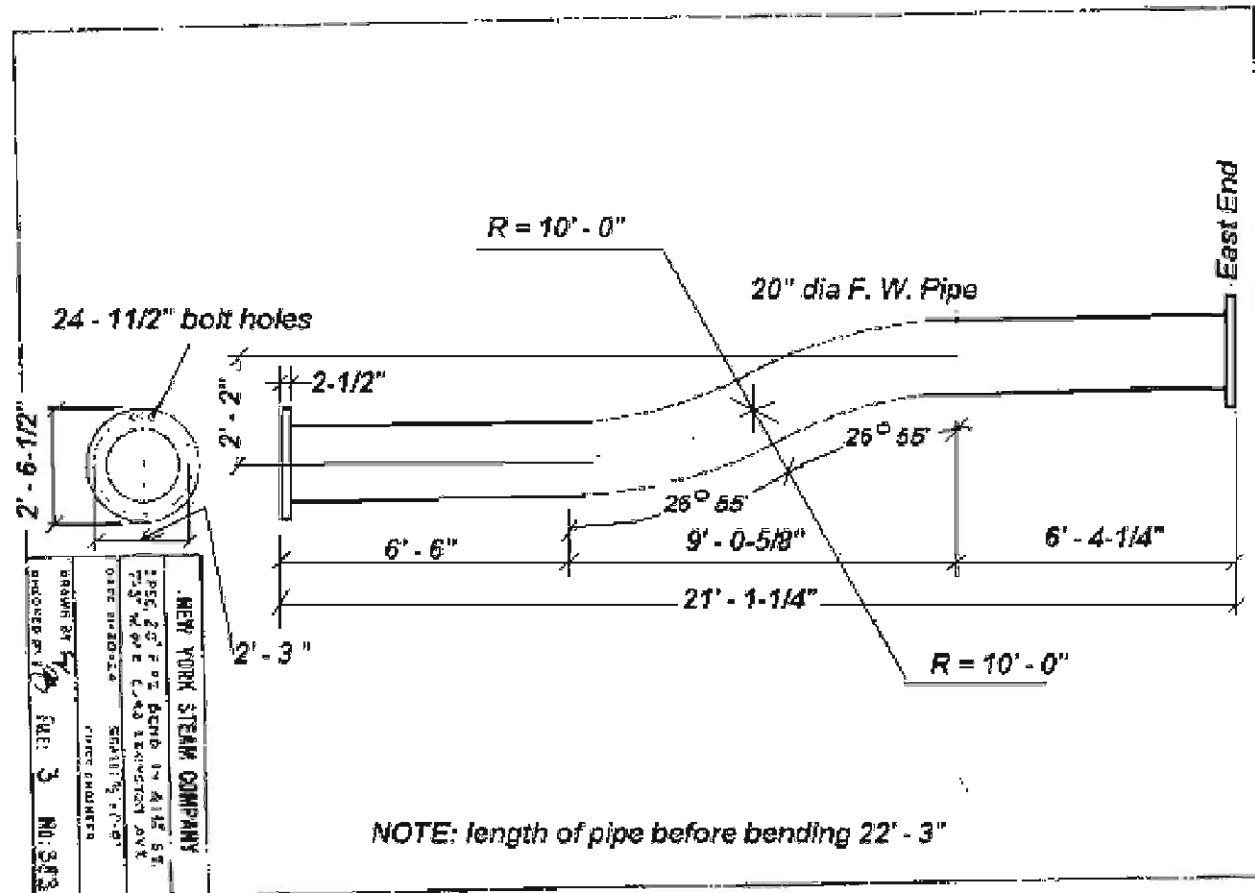
Figure 2-2: Drawing of File 3 Bend Utilized on East Side of Lexington Avenue

A drawing of the failed pipe bend is shown in Figure 2-2. This type of pipe bend is referred to as a File 3 bend, based on the drawing identification numbers for these components. The typical manufacturing method in the 1920's for this pipe bend type is a seam-welded pipe. Two seam welding methods were typically used: lap welding and butt-welding. Lap welding was commonly used for piping greater than 2" diameter and butt-welding for smaller diameter pipes. The lap-welded method was used for this piping. Few standards existed at the time for steel pipe properties, but the pipe material metallurgical properties were consistent with 1920s and current day pipe materials such as the ASTM A-53 pipe standard [8, 13].

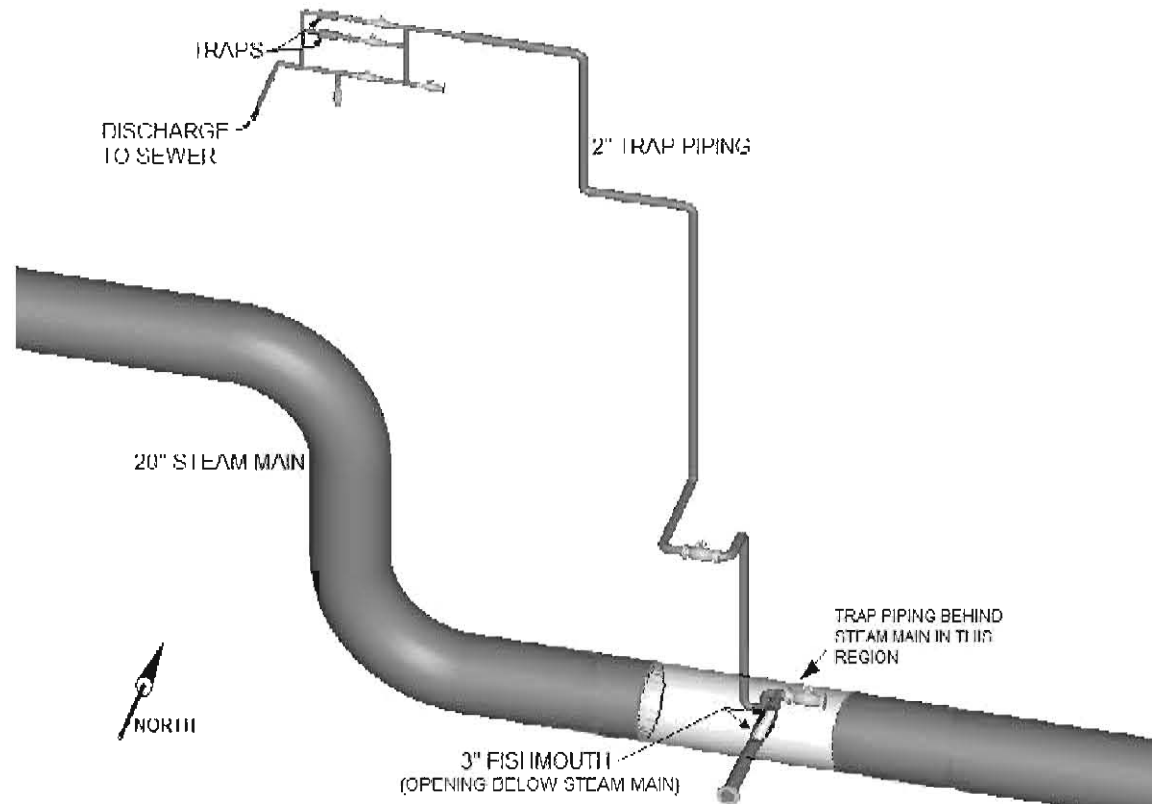
Figure 2-5: Trap Line Layout (Looking North)

The pipe drain location was within drain manhole #6114 on the intersection west side. Condensate was collected in a configuration typically referred to as a “fish-mouth” type drain, consisting of a 3” pipe cut horizontally into the bottom of the 20” steam main and oriented perpendicularly to the main pipe. A 2” diameter pipe carried condensate through a small loop-seal and then up to trap manhole # 7338A (See Figure 2-5). Two 1” Gestra model DK-57H steam traps were installed in this trap assembly.

(The trap line take-off point at the 3" fish-mouth drain was located within the drain manhole as shown on Figure 1-2)

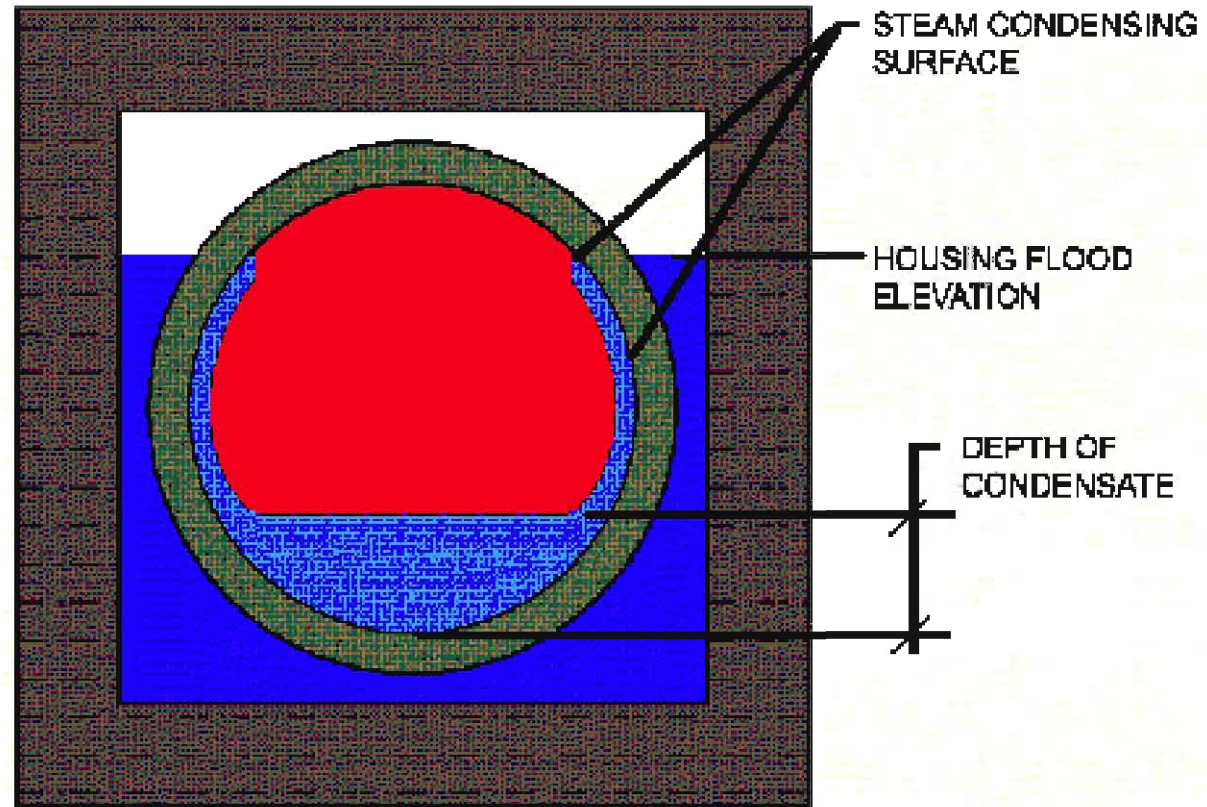
Figure 3-1: Condensate Accumulation from External Flooding in Housing

The external housing and manhole flooding caused very rapid condensation inside the pipe. The condensate that formed built up and filled the pipe. This eliminated steam flow in the pipe at this location in the steam distribution network. The condensate remained inside the pipe below the intersection until late in the afternoon, during which time the condensate temperature dropped below the temperature of the steam.

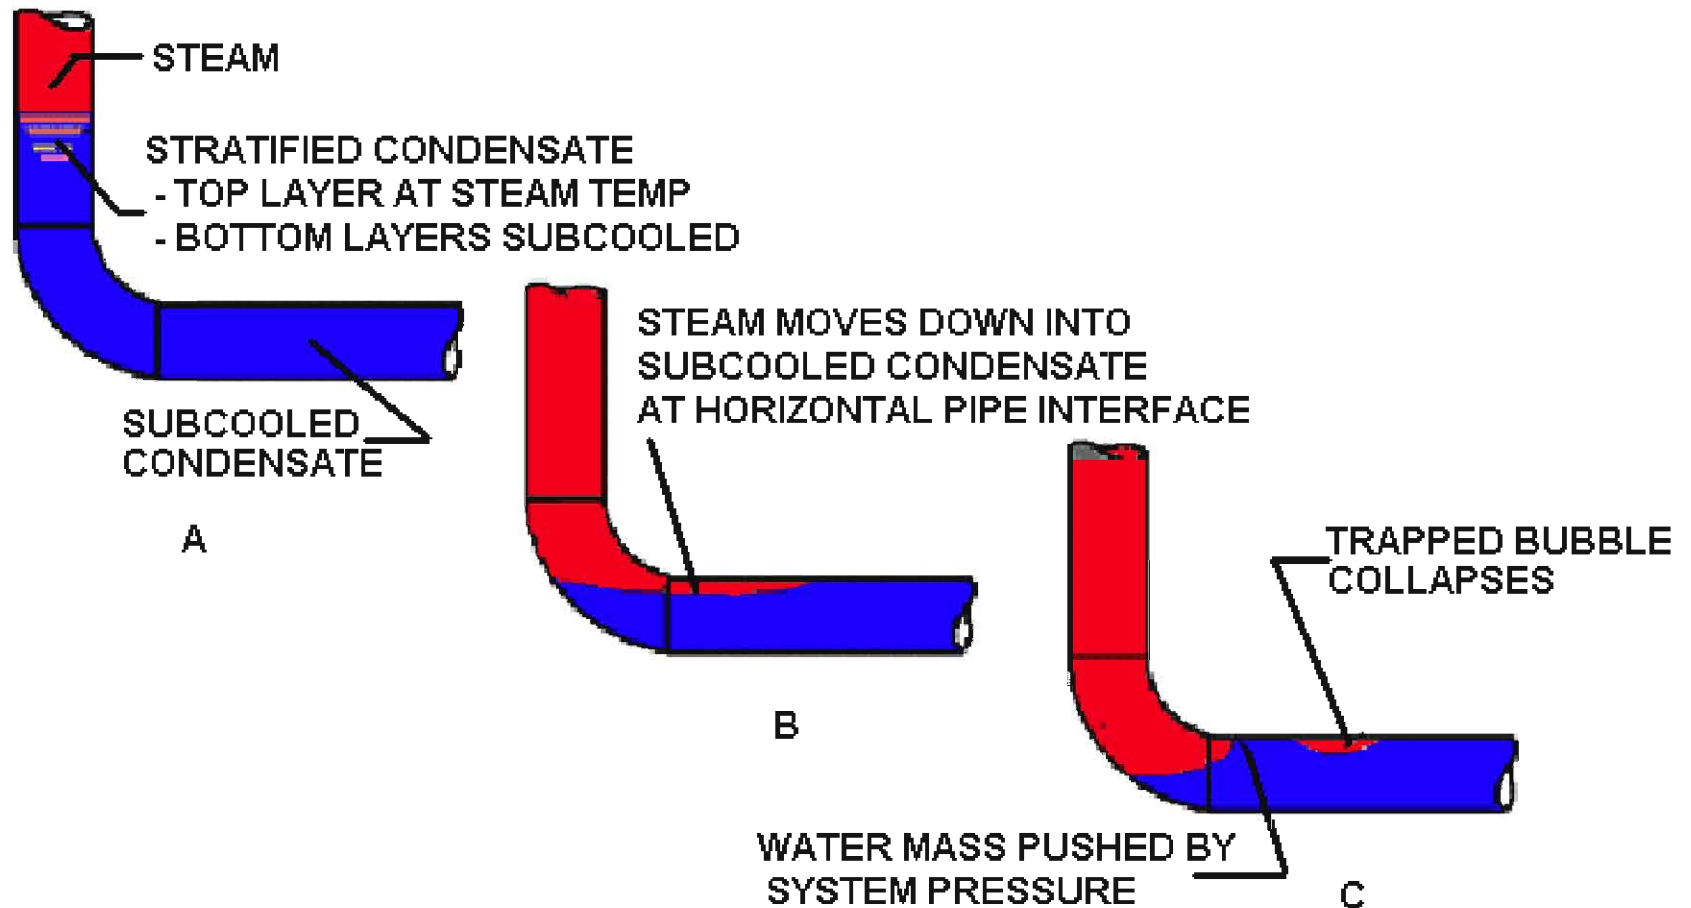
Figure 3-5: Scenario for Bubble Collapse Waterhammer

A condensation induced waterhammer occurs when a steam bubble enters a region of somewhat cooler condensate and becomes trapped. The steam in the trapped bubble condenses to water very rapidly and creates a void – a space where the bubble previously existed. The normal pressure of the steam causes the surrounding condensate to rush to fill the void left as the steam bubble collapses. The rushing condensate mass impacts itself and creates a large pressure pulse in a fraction of a second. The steam's normal pressure is approximately 160 pounds per square inch (psig). The pressure pulse resulting from a waterhammer can be as large as 1,000 to 2,000 psig.

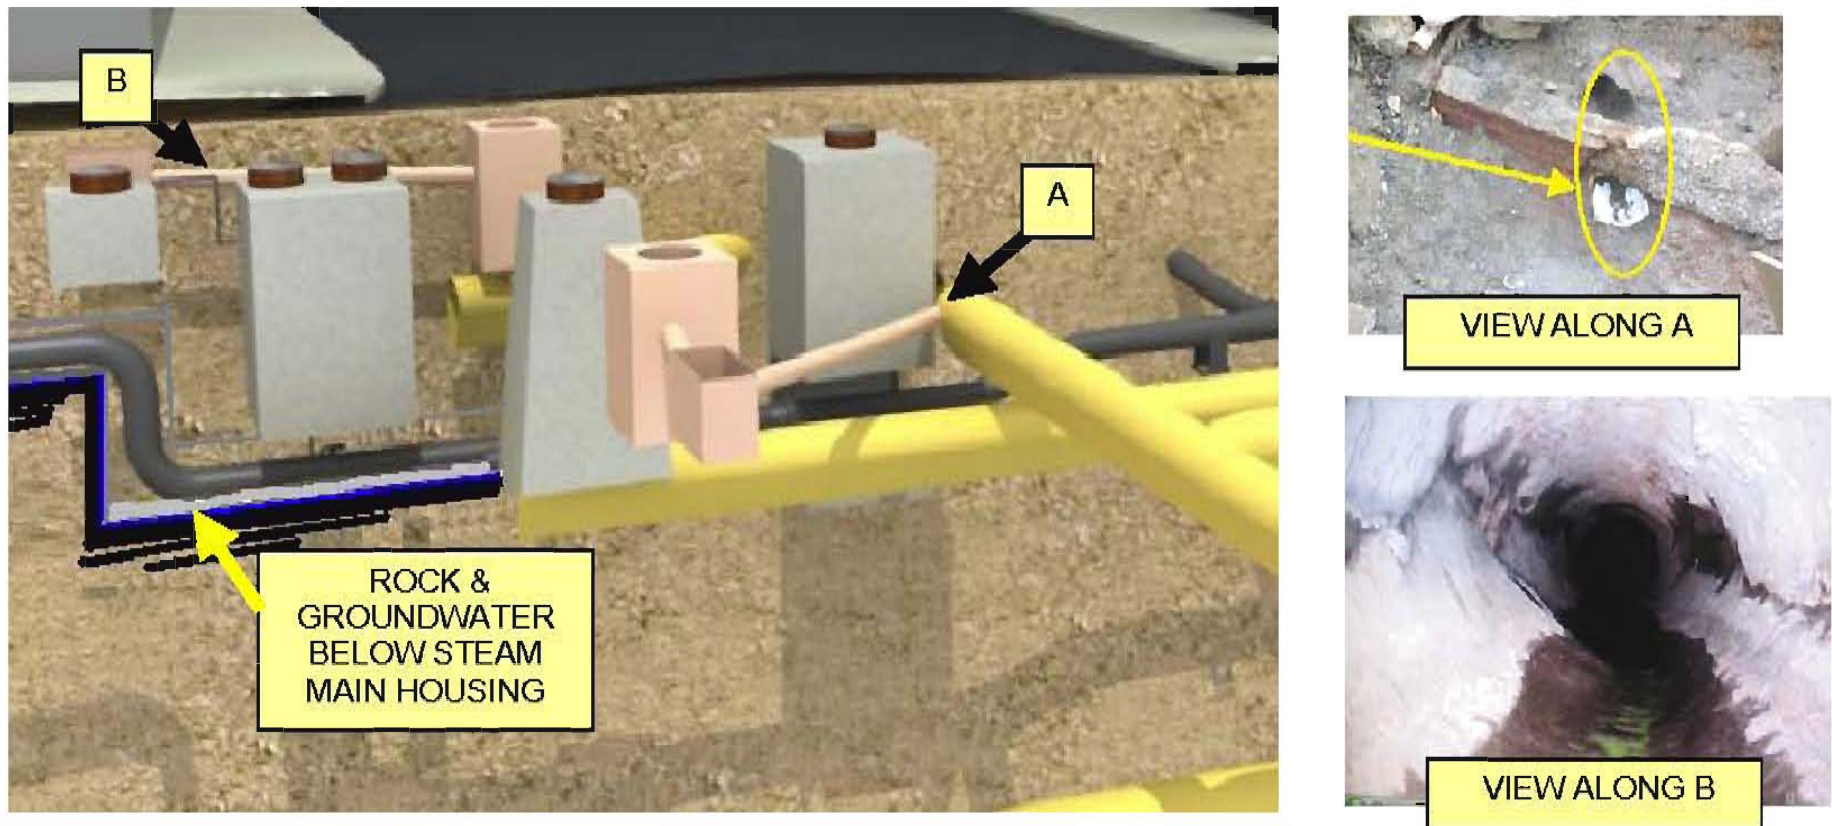
Figure 4-9: Depiction of external water issues at intersection

direct and in-direct infiltration from the adjacent northwest catch basin, a rise in the local water table during the rain event, possible pressurization of the sewers under heavy rain conditions, and potentially leaking water mains, increasing the elevation of the water table.

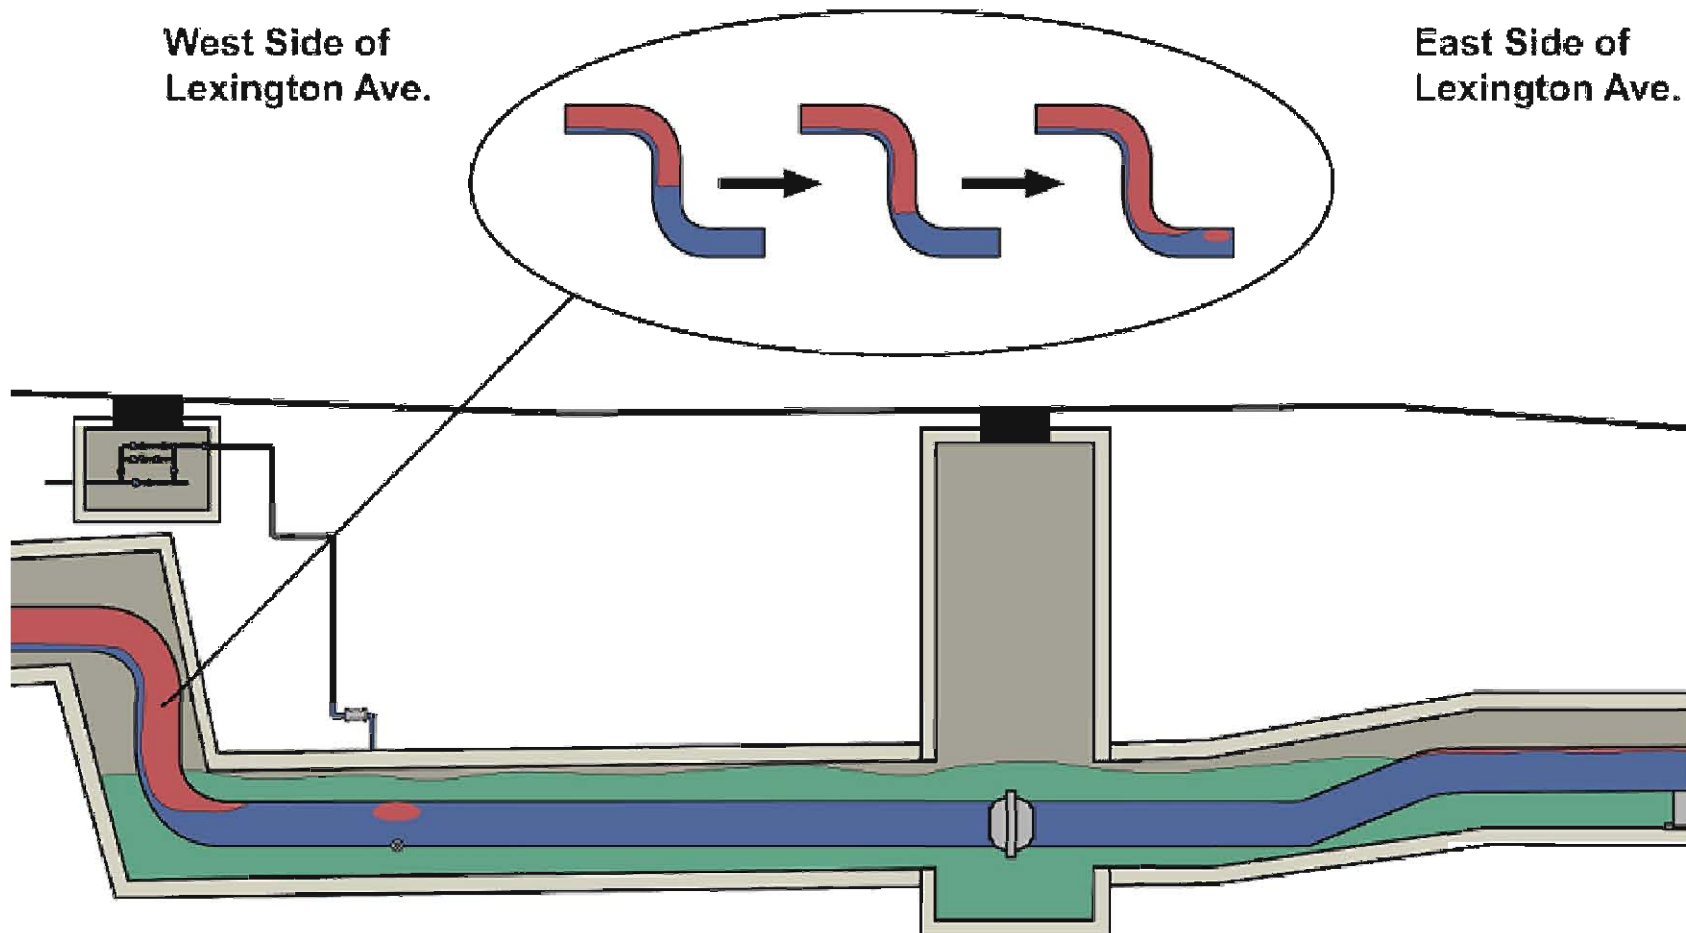
Figure 5-3: Steam Flows into Subcooled Condensate as Differential Pressure Across Intersection Increases

Just before the pipe rupture, routine system adjustments, including the movement of valve CV-3 and a reduction in steam output to match demand, resulted in the steam flow in this region entering the cooled condensate that had collected in the pipe at the Lexington Avenue intersection. This initiated a condensation induced waterhammer.

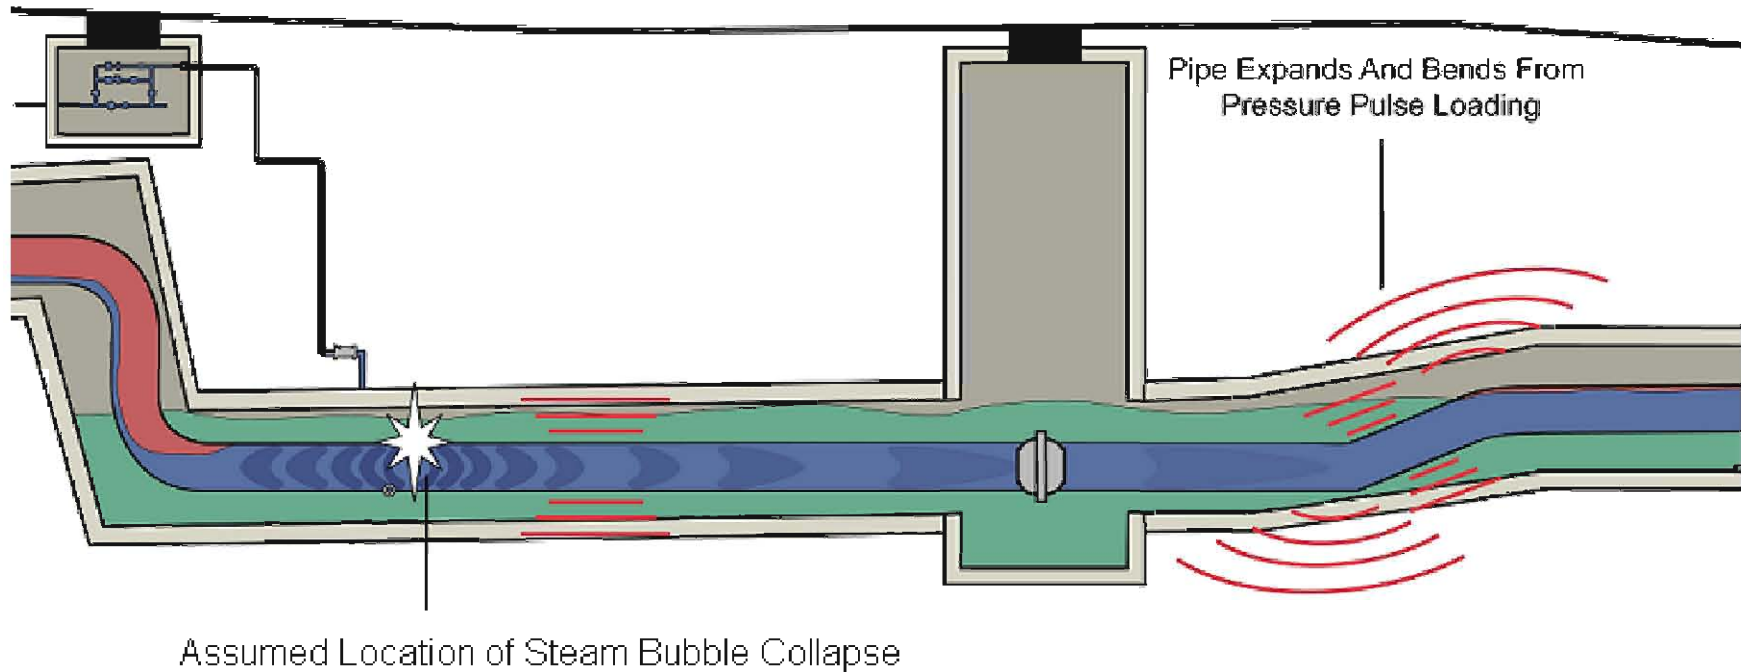
Figure 5-4: Steam Bubble Collapses Creating Pressure Pulse that Ruptures Steam Main

region at the east side of the intersection resulted in the pipe stress exceeding the strength of the material. This caused the pipe to rupture.
